THE DARIEN BOAT CLUB INCORPORATED

Permit Application for Temporary Repairs after Super Storm Sandy

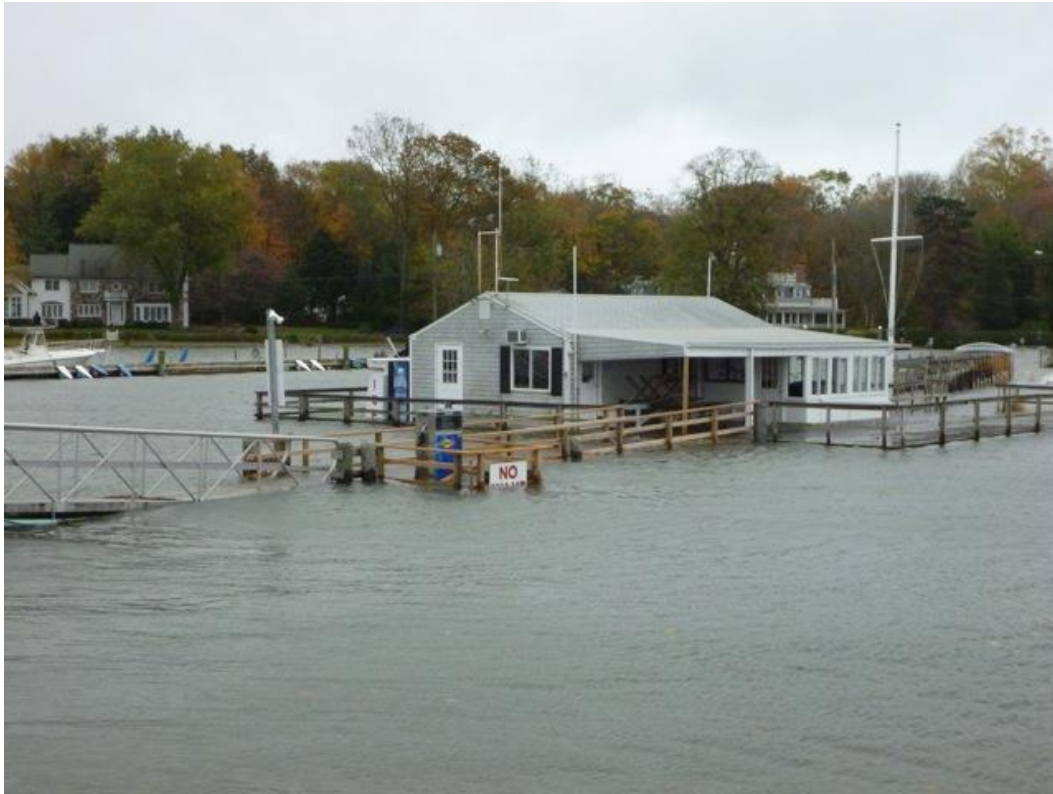
The picture shown above is of the noon tide when the wind was coming from the North. The main damage was done during the evening tide when the wind and waves were out of the South.

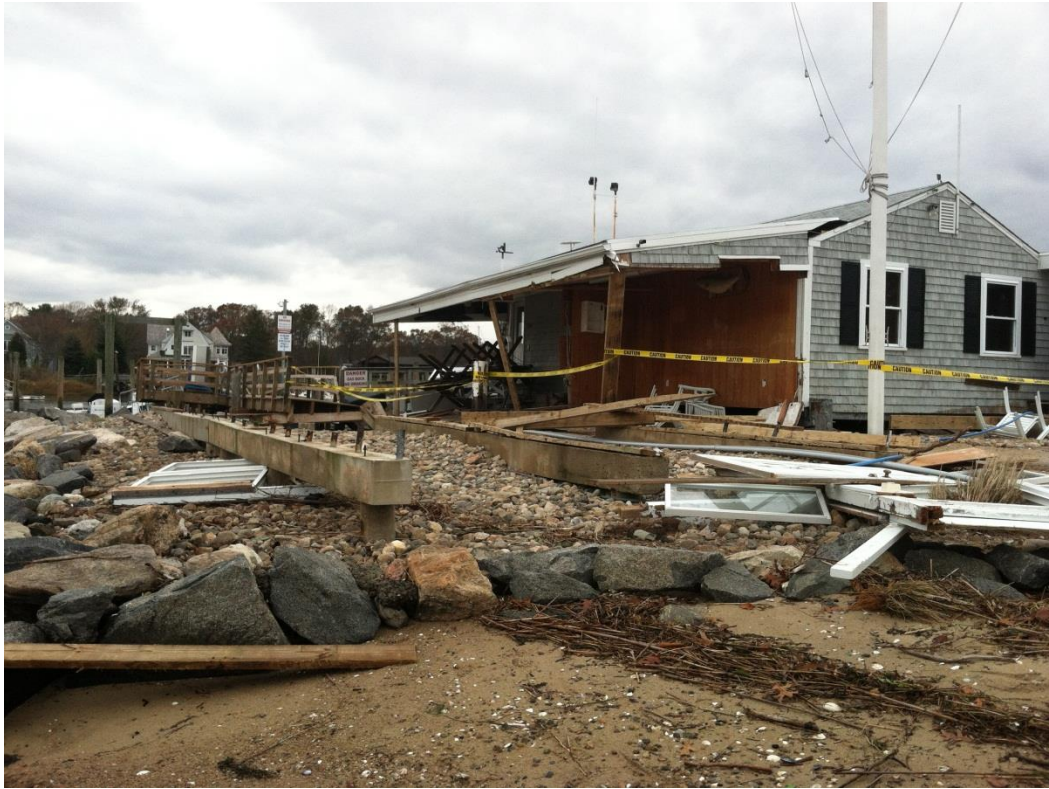
After the storm, the front part of the deck was destroyed as well as the awning and sunroom on the West side of the club building.

For the safety of our members and the Darien residents and to prevent further environmental damage, it was decided to deconstruct the damaged sections of the building. Prior to doing this, we discussed the situation and gained concurrence from Planning and Zoning. We then wrapped the building with a tarp to protect it from the winter weather and any additional storm damage. We also cleaned up the significant debris field that formed along the beach and across the access to the club.

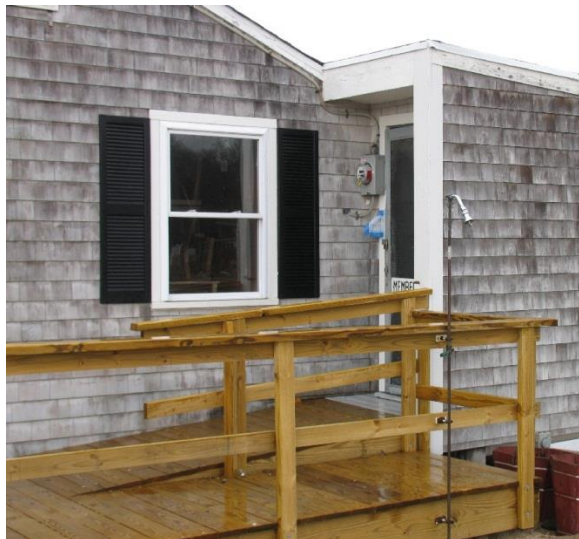
A picture of the existing window that will be replaced with a temporary door is shown:

- Install code compliant railings on all new sections of decking that is more than 30” above grade (denoted by red lines on the diagram)
- Replace the window on the South side of the club by the toilets with a 32” door into the existing locker room.

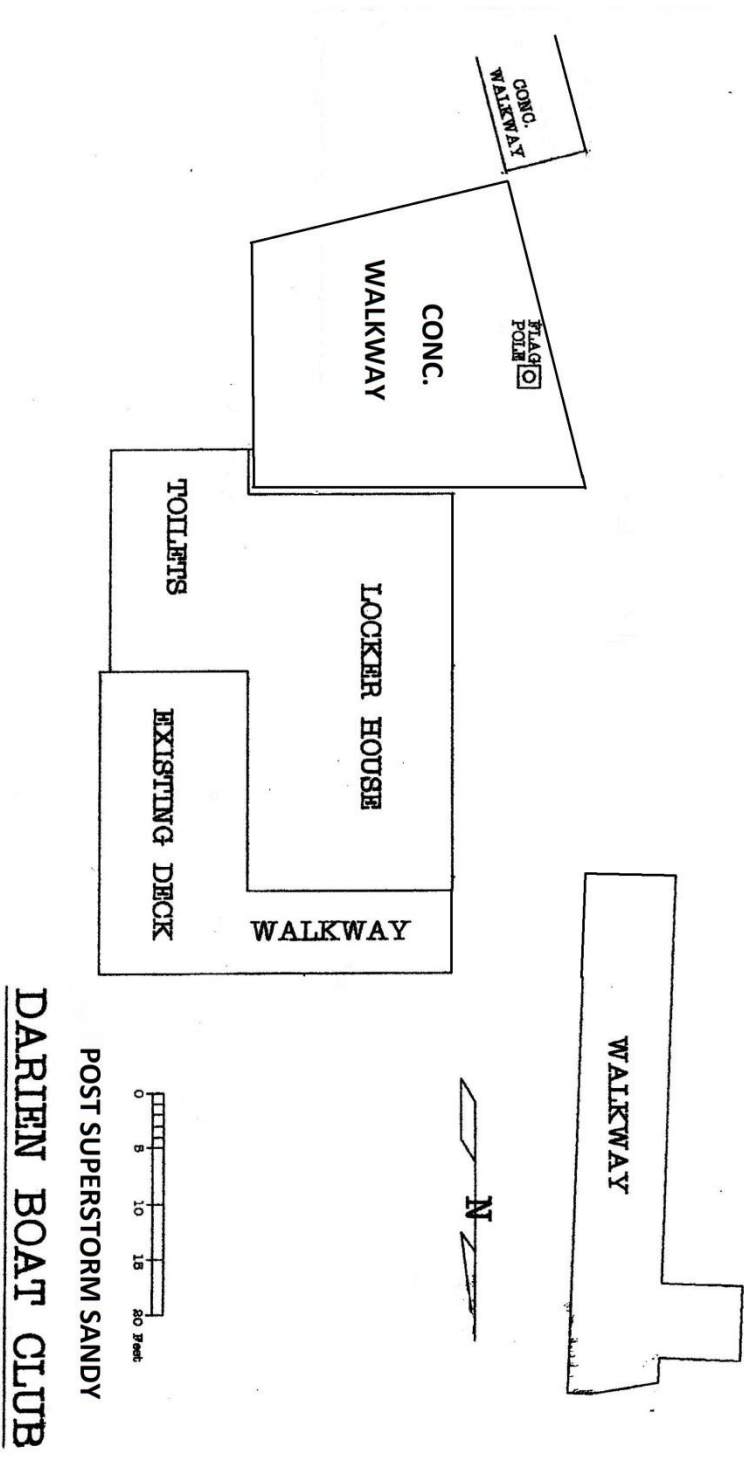
Diagram 2

On the following 4 pages are the diagrams referred to in this discussion. The first diagram is the club “pre-Sandy” as it existed. Diagram two is what was left after the storm and subsequent efforts to make the area safe. Diagram 3 shows the plan for the temporary repairs. Finally Diagram 4 is the interior structure of the club and shows how we are going to access the docks through the building. The reason for dock access through the building is that it clears the areas where the permanent repairs will be taking place. Thus, if the club receives the necessary approvals during the boating season, construction can start immediately and be completed as soon as possible.

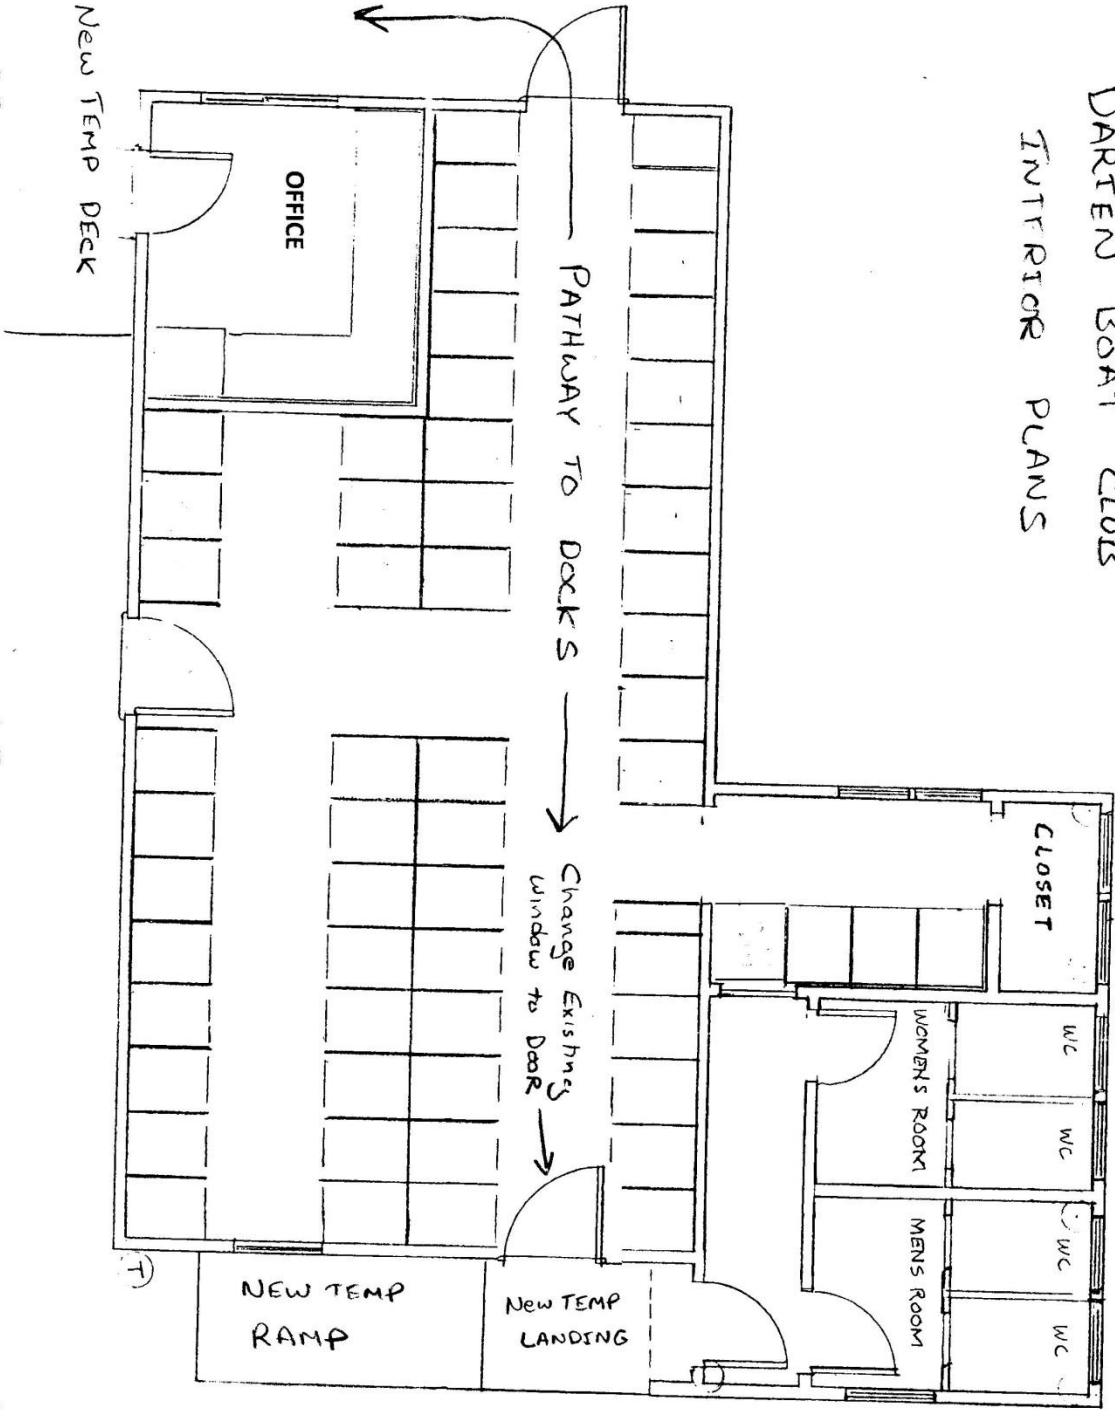
Diagram 4 shows the path through the interior of the club to provide access to the docks.
