THE DARIEN BOAT CLUB INCORPORATED

Permit Application for Temporary Repairs after Super Storm Sandy

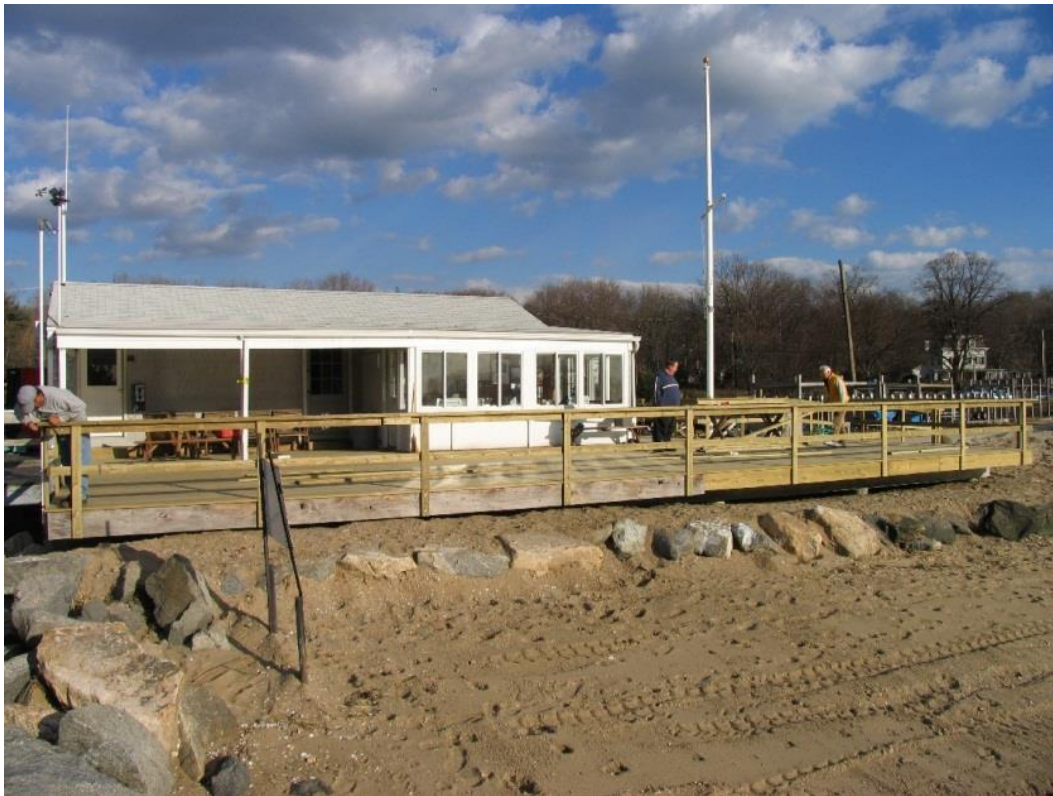
Prior to the storm the club had a beautiful deck that was increased in size and finished in 2004.

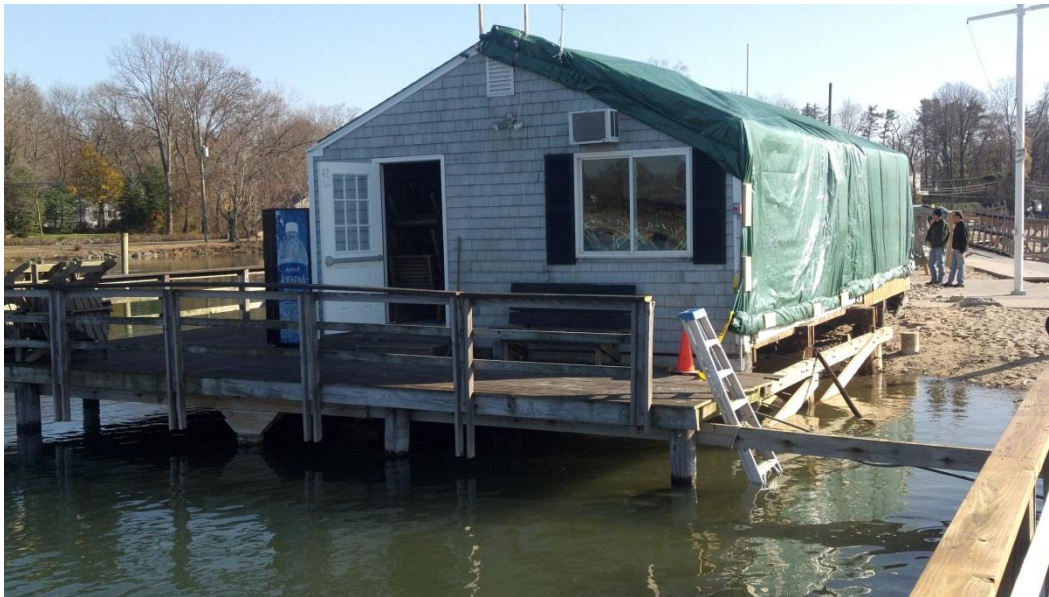
After the storm, the front part of the deck was destroyed as well as the awning and sunroom on the West side of the club building.

For the safety of our members and the Darien residents and to prevent further environmental damage, it was decided to deconstruct the damaged sections of the building. Prior to doing this, we discussed the situation and gained concurrence from Planning and Zoning. We then wrapped the building with a tarp to protect it from the winter weather and any additional storm damage. We also cleaned up the significant debris field that formed along the beach and across the access to the club.

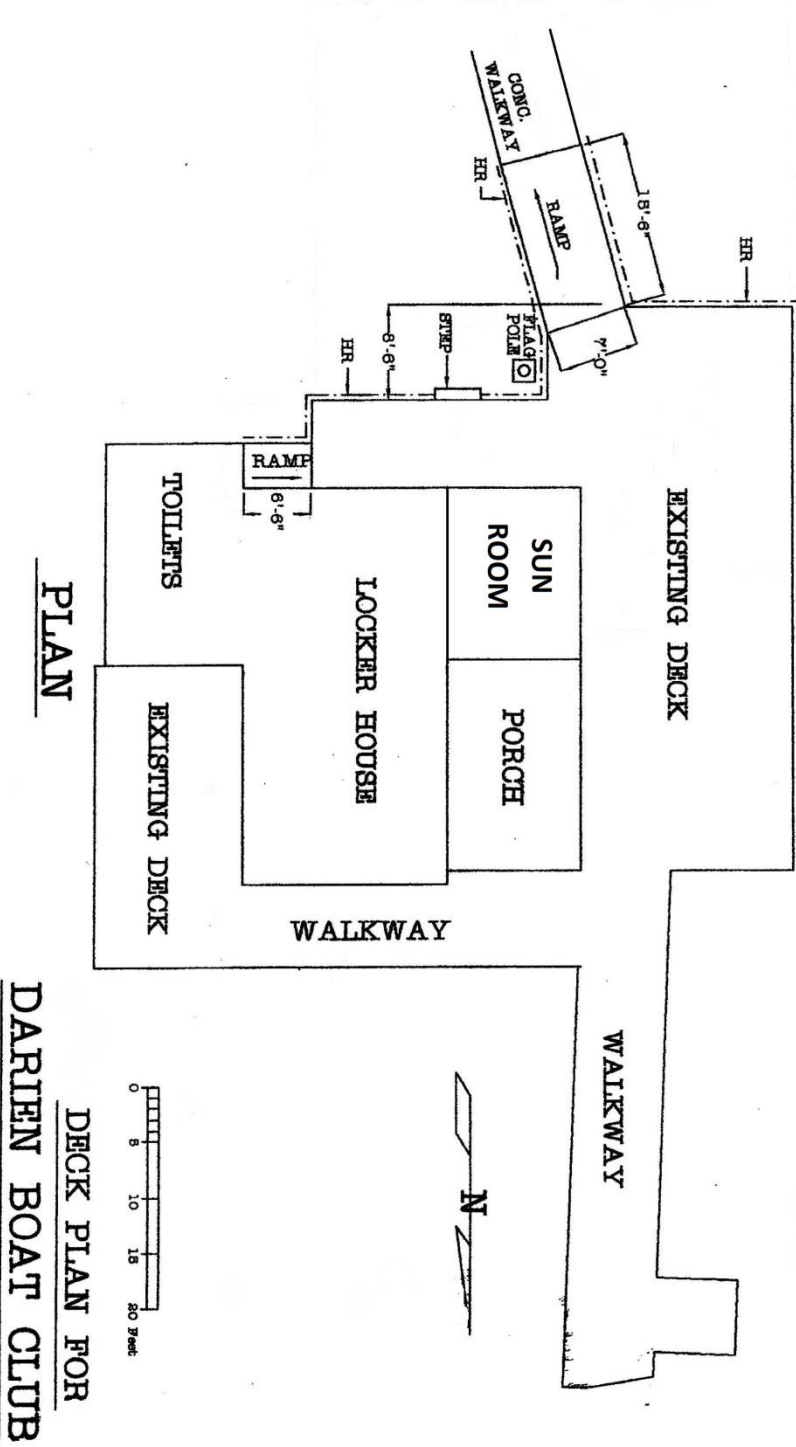
Diagram 1

On the following 4 pages are the diagrams referred to in this discussion. The first diagram is the club “pre-Sandy” as it existed. Diagram two is what was left after the storm and subsequent efforts to make the area safe. Diagram 3 shows the plan for the temporary repairs. Finally Diagram 4 is the interior structure of the club and shows how we are going to access the docks through the building. The reason for dock access through the building is that it clears the areas where the permanent repairs will be taking place. Thus, if the club receives the necessary approvals during the boating season, construction can start immediately and be completed as soon as possible.
